## Durham Swimming Pool Assessment Study

In the Spring of 2014, Szostak Design was commissioned by the City of Durham General Services Department to prepare a comprehensive assessment of the city's five aquatic facilities and four spraygrounds. The study was to identify and prioritize aquatic, mechanical, electrical, plumbing, structural, accessibility and energy efficiency deficiencies at each facility and include an analysis of current conditions and recommendations for improvement<sup>1</sup>. A cost model of recommended repairs and improvements was to be included in the study, as well as a projection of annual maintenance costs anticipated for each facility.

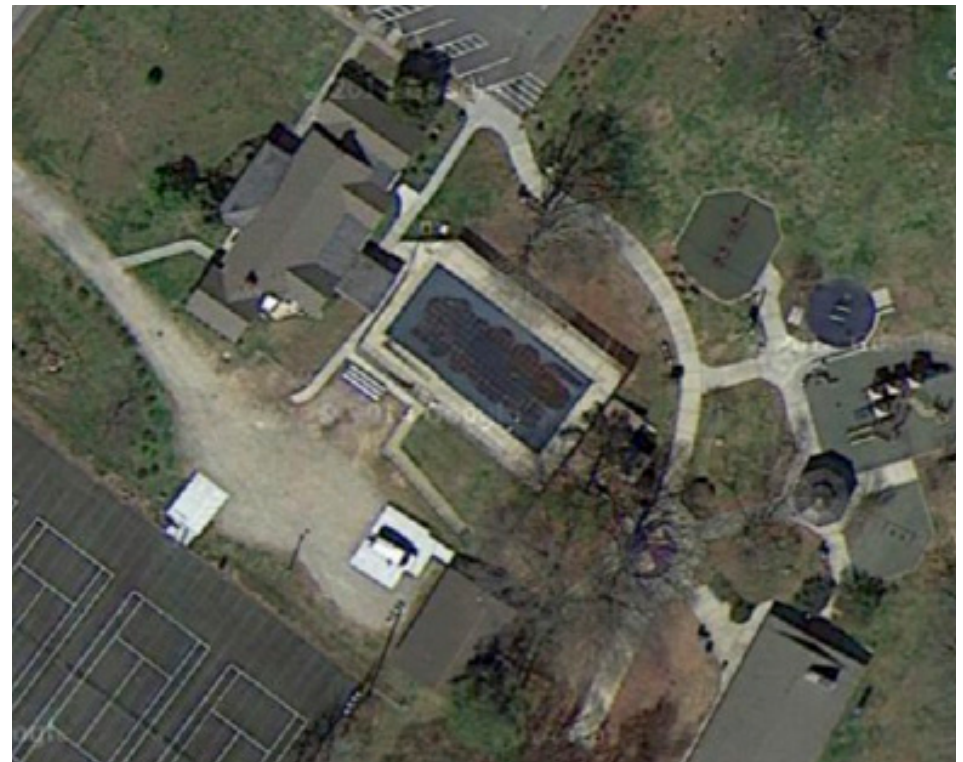
Clockwise from Top Left:  
Forest Hills Pool aerial  
photograph showing extent  
of flood plain (blue). The  
pool shell as seen from the  
northwest. An aerial view of  
the facility.

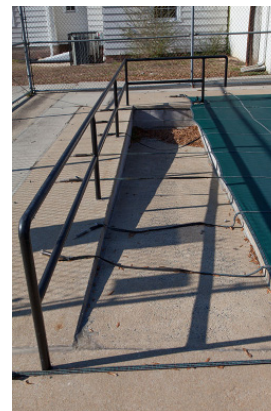
The facility's dry ramp is no longer permissible as an ADA-compliant means of accessing the swimming pool.

Middle Left:  
Dry ramp west of the pool  
shell.

Recommendation: Install an ADA-compliant lift on the deck near the shallow end of the pool. The installed position of the lift must not constrict the minimum deck width of eight feet. Accordingly, a location in the northeast corner of the deck is recommended. However, this location may create a conflict with an existing pool access ladder. If the existing dry ramp is infilled (see FH.14) to

provide a clear deck width of 13 feet, a location at the northwest corner of the deck would also be suitable. A battery-operated lift is recommended.

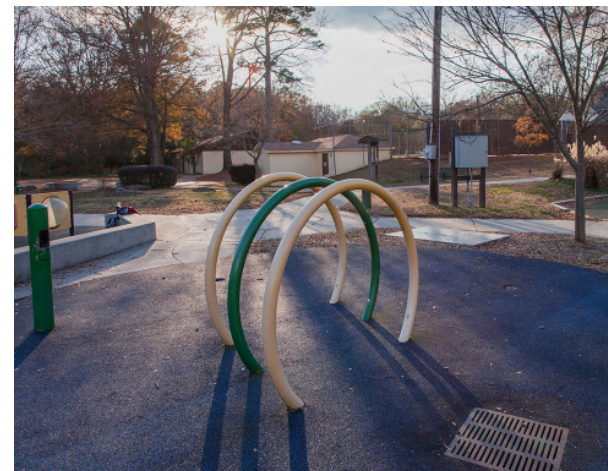
Bottom:  
Forest Hills Sprayground.

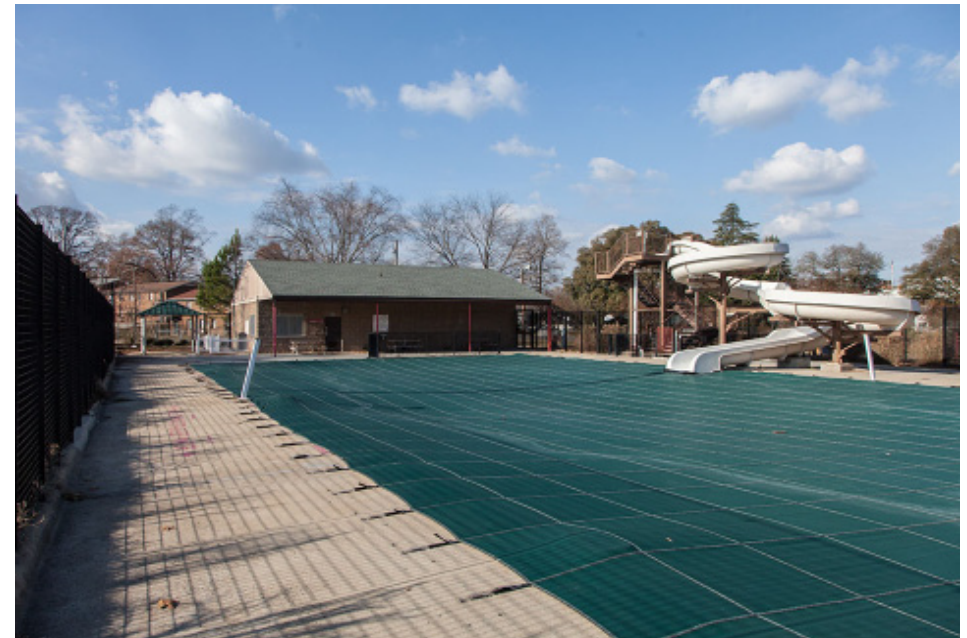
Top:  
Long Meadow Pool with  
off-season pool cover installed.

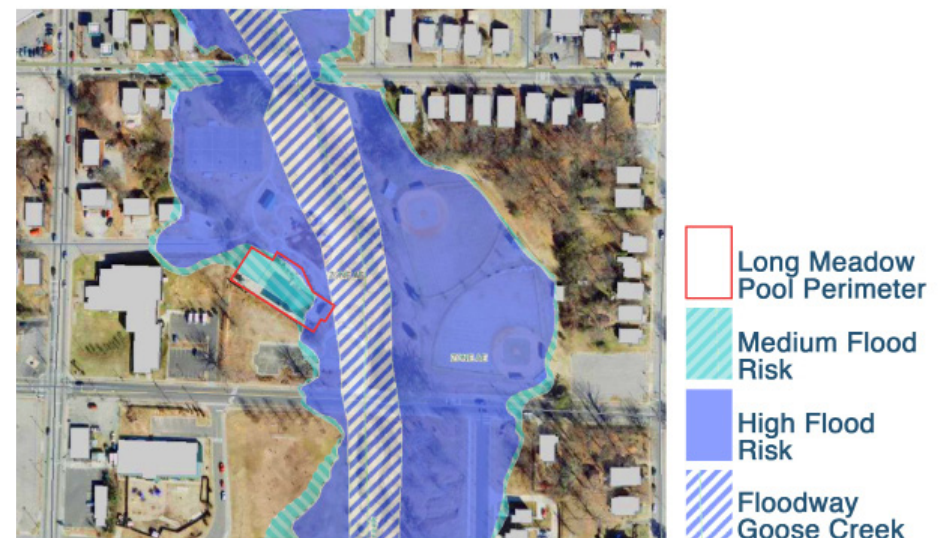
Bottom:  
Aerial photo of Long Meadow Pool  
showing extent of Flood Plain  
(solid blue) and 1% Future  
Conditions Flood Plain (stripped  
aqua blue).

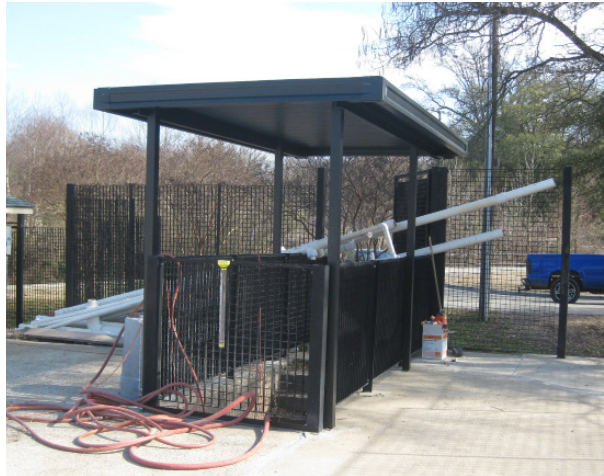
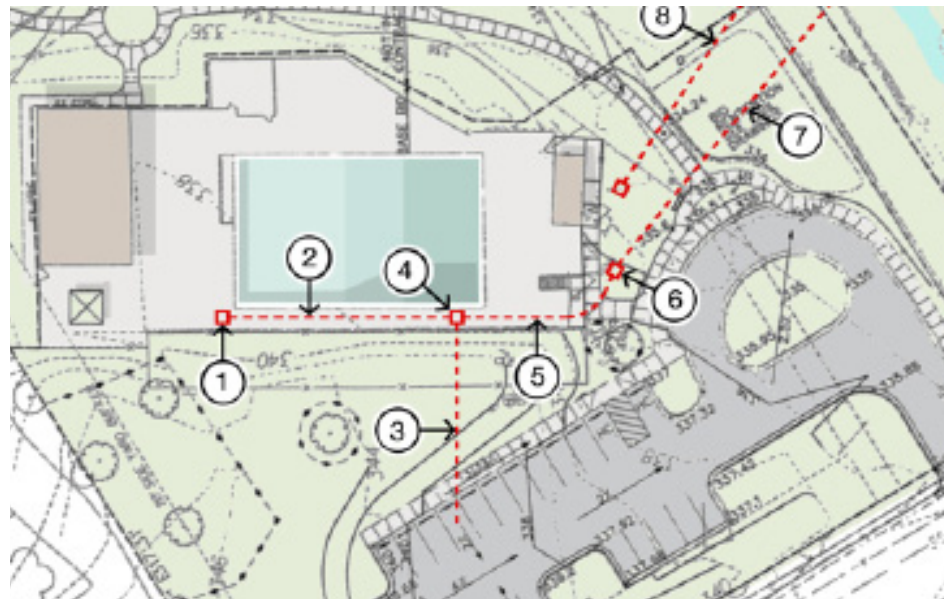
Below:  
Preliminary mapping of deck storm  
drain inlets and lines (assumed,  
prior to field survey)

1. Storm drain deck inlet.
2. Under deck drain line.
3. Drain line from parking lot.
4. Storm drain deck inlet.
5. Drain line under deck.
6. Field inlet.
7. Clogged or collapsed drain line.
8. Unrelated drain line.

Recommendation: The recommended pool shell leak repair work has been substantially completed at the time of this writing. If subsequent testing reveals additional leakage, further remedial measures may be necessary. At present, no cost for such remediations is included in the estimate of repair costs until it is determined whether additional repairs will be necessary.

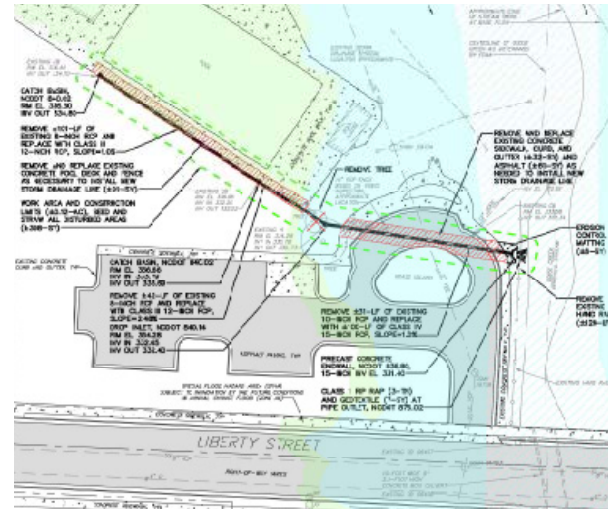
Left:  
Construction plan for replacement of clogged stormwater line at Long Meadow Pool by Stormwater and GIS Services Division, Public Works Department, City of Durham, North Carolina - Contract: SD-2013-01; Project COP-038.

If water infiltration into the Pump Room has not been successfully mitigated by the repairs described above, it is recommended that a foundation drain line be installed immediately outside the southwest enclosure of the pool. The design of this foundation drain would require detailed engineering consultation, including topographic and boundary surveying, a sub-surface soils investigation, hydrological studies defining the quantity, depth and path of groundwater, permitting and regulatory applications, preparation of bid documents and contract supervision. The work would need to be publicly bid. The project, including engineering and regulatory approval would require at least nine to twelve months to complete, pushing the potential re-opening of the pool to at least the 2016 summer season. A preliminary estimate for the cost of this work totals \$135,000 and is not included in the current Long Meadow Repairs Budget.

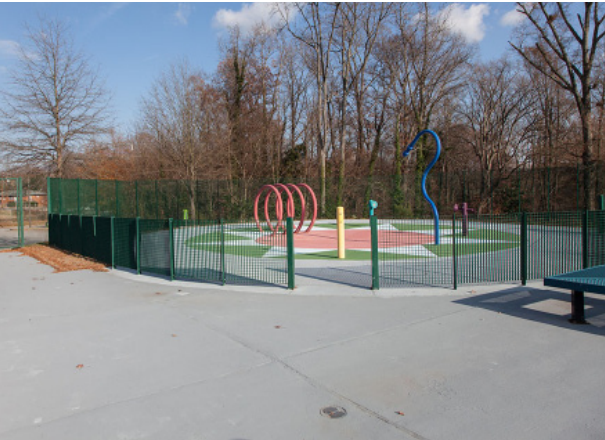
Top:  
The sprayground is within the general pool enclosure area and is available for use only when the Hillside is open.

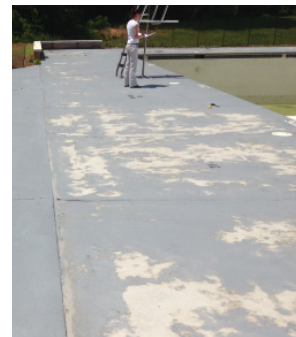
Middle Left:  
Deteriorating pool deck finish.

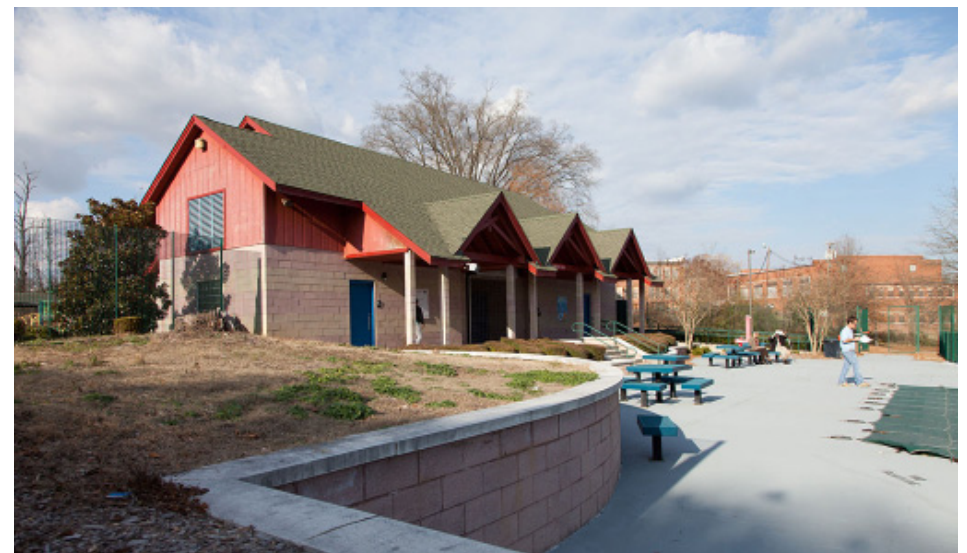
Top:  
A. Cashier's window.  
B. Path of patron circulation out of view of cashier.

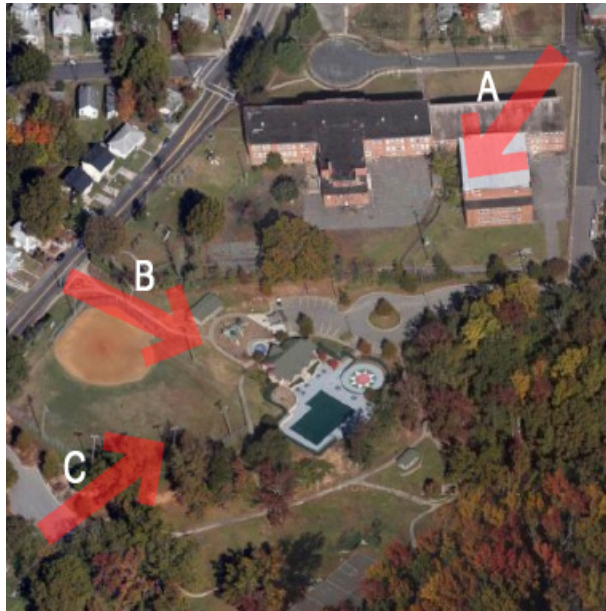
Top:  
Aerial view of Hillside Pool showing points of access from public streets.

Recommendation: Provide well-designed identification and directional signage positioned in conspicuous locations at the edge of the park, adjacent to both streets that provide patron vehicular access to the pool.

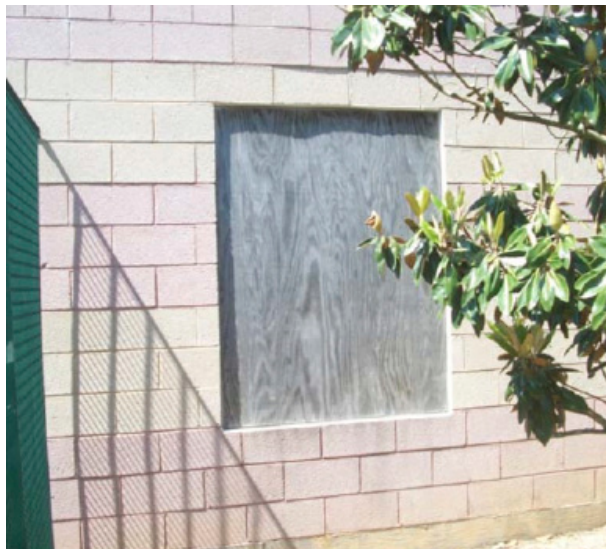
Bottom:  
Unfinished plywood infill panel at window opening.

A window opening into the Women's Locker Room has been infilled with an unpainted plywood panel over a Plexiglas panel. At minimum, the plywood should be painted. Preferably, the windows should be restored with break-resistant obscure glass or durable, translucent Plexiglas. As this renovation is primarily aesthetic in nature, it could be deferred indefinitely. Accordingly, no opinion of probable cost is included in the repair and renovation budget.

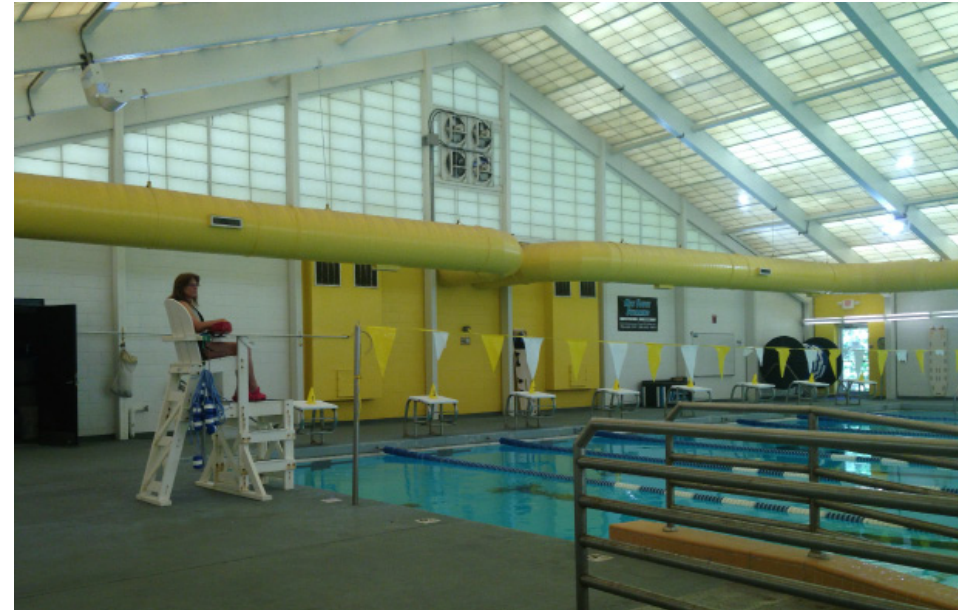
The gutter overflow system is continuous around the pool's perimeter and is covered with PVC grates. In a Natatorium, the HVAC and ventilation system play an important role in maintaining good indoor air quality and a non-corrosive environment. The temperature and relative humidity in the Natatorium continue to be an issue as the Pool Pak compressor does not operate as designed. Signs of corrosion are evident around

Top:  
Natatorium.

the Natatorium including bolts on the lifeguard stands, starting blocks and ladders as well as the drinking fountain. The deck space is marginal around the pool and the concrete deck finish is deteriorating in multiple areas.

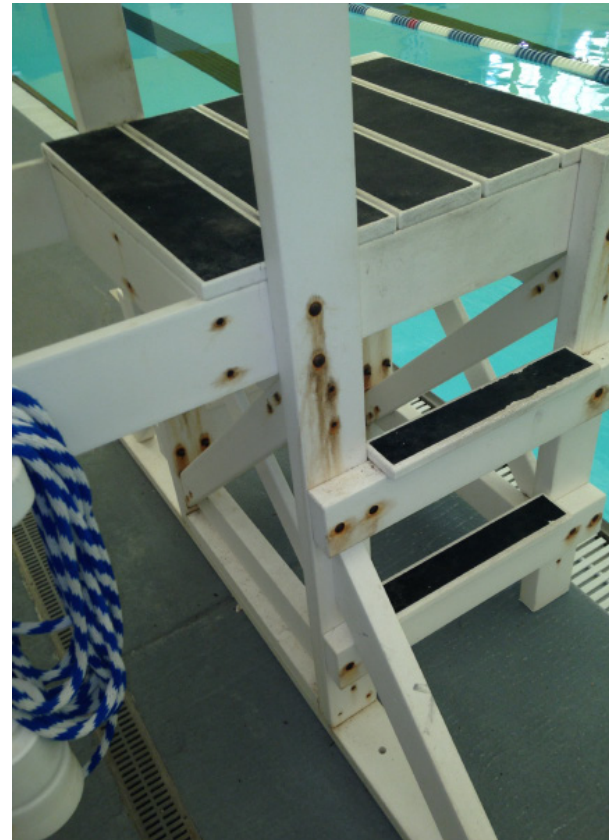
Bottom:  
Typical corrosion of  
pool equipment.

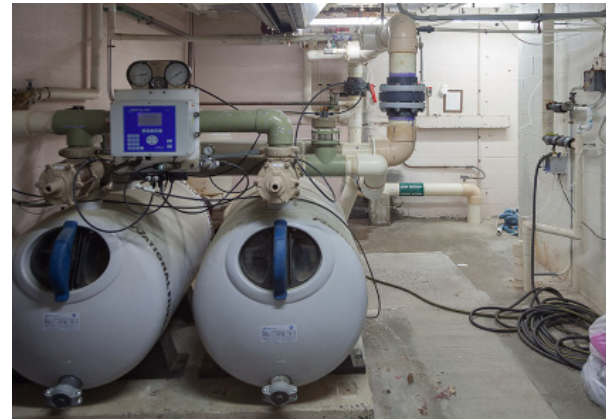
Top:  
Pump Room.

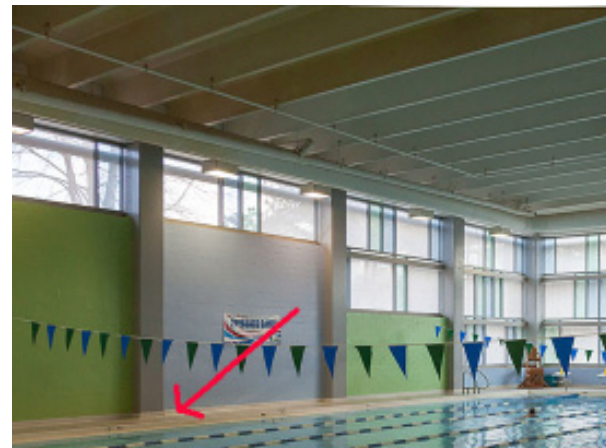
Middle Left:  
Inaccurate depth markers.

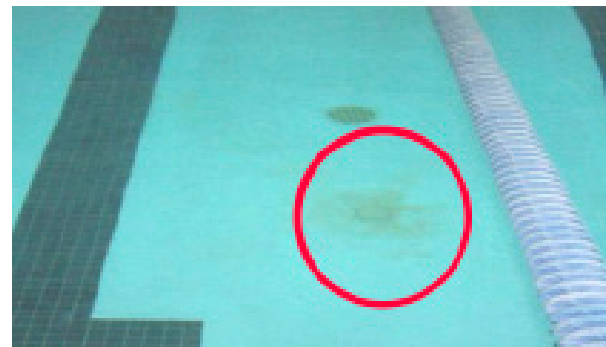
The pool's recirculation pump is in good condition. The filter is operating efficiently, but may have damage to one or more of its laterals, causing loss of filtration sand. There are two National Filters, model 34-100-135-T, with each pool filter having a maximum flow rating of 270 gpm. The filter system has an automatic backwash system.

Bottom:  
Sand accumulation in pool shell  
suggesting filter damage.

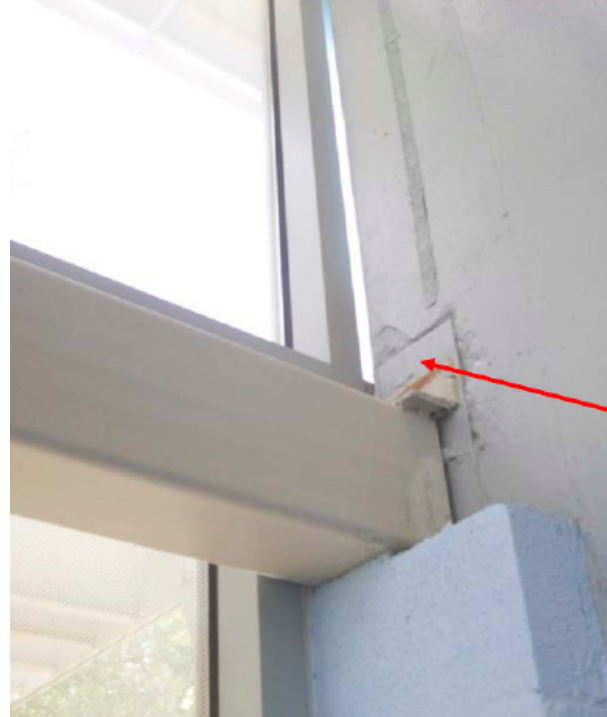
Bottom Left:  
Minor corrosion of steel lintel at  
lower level entrance
